# VILLAGE OF HARRISON HOT SPRINGS NOTICE OF MEETING AND AGENDA

## REGULAR COUNCIL MEETING

THAT the Harrison Hot Springs Village Waterfront Hydrotechnical Assessment, by NHC and dated May 30, 2022 be received for information.

## Harrison Hot Springs Village Waterfront Hydrotechnical Assessment

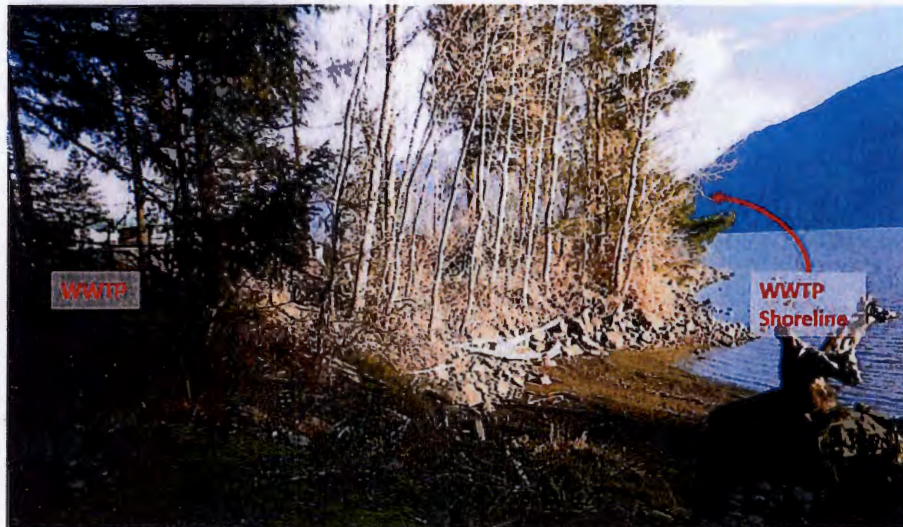
Zone 1 is the smallest zone, limited to the WWTP. At the time of inspection the shoreline of the WWTP was not directly inspected. From afar, findings in this zone included large collection of driftwood on the riprap slopes and extensive vegetation at the top of the slopes (Figure 3.3). Note that an inspection of this zone is planned for a later date.

Figure 3.3 Zone 1 – View of the WWTP shoreline from the south.

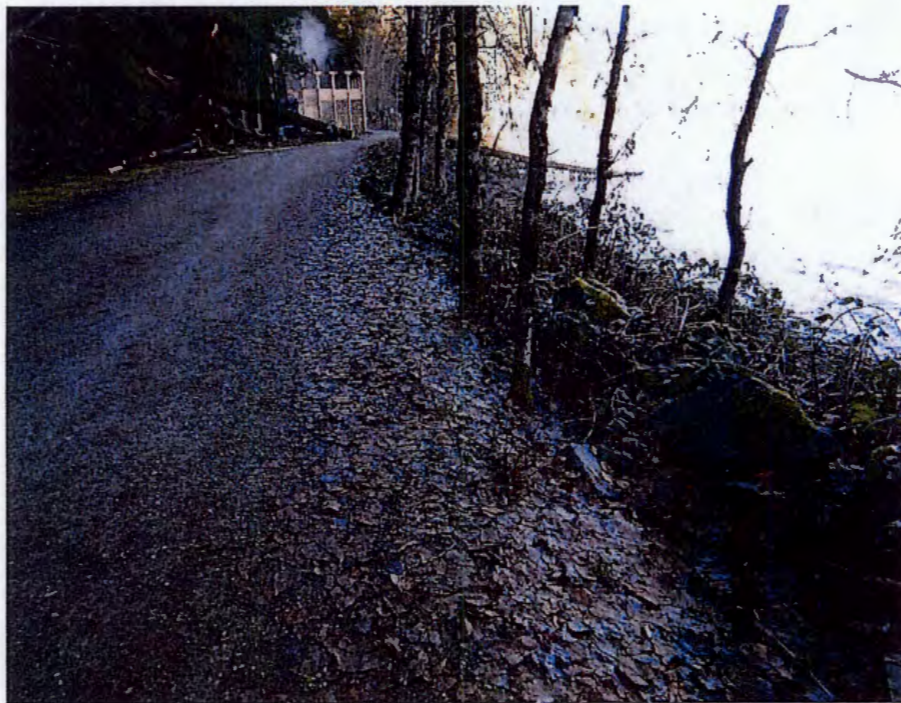
Figure 3.4 Zone 2. Access road to the WWTP includes tree growing at the top of the armoured slope.

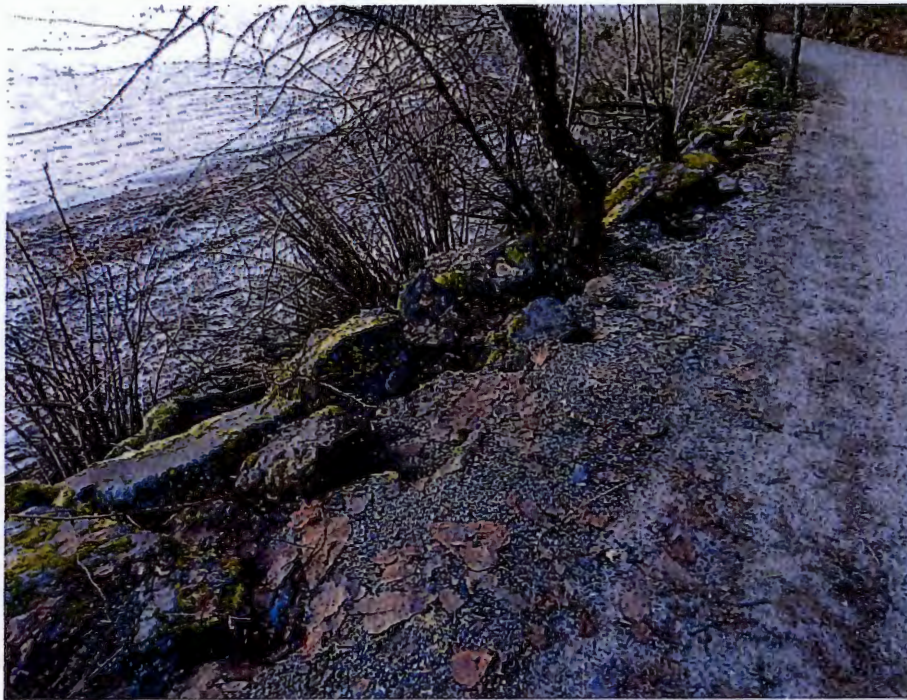
- There is a notable loss of road fill at the top of the riprap slope at a number of locations. This is likely due to the lack of a filter layer (either rock or geotextile) which is prohibiting the riprap from functioning properly. (Figure 3.5). There are visible repairs at the top of the slope where fill that had previously washed out has been replaced. (Figure 3.6)

Figure 3.5 Zone 2 – Repaired erosion along the top of the riprap slope.

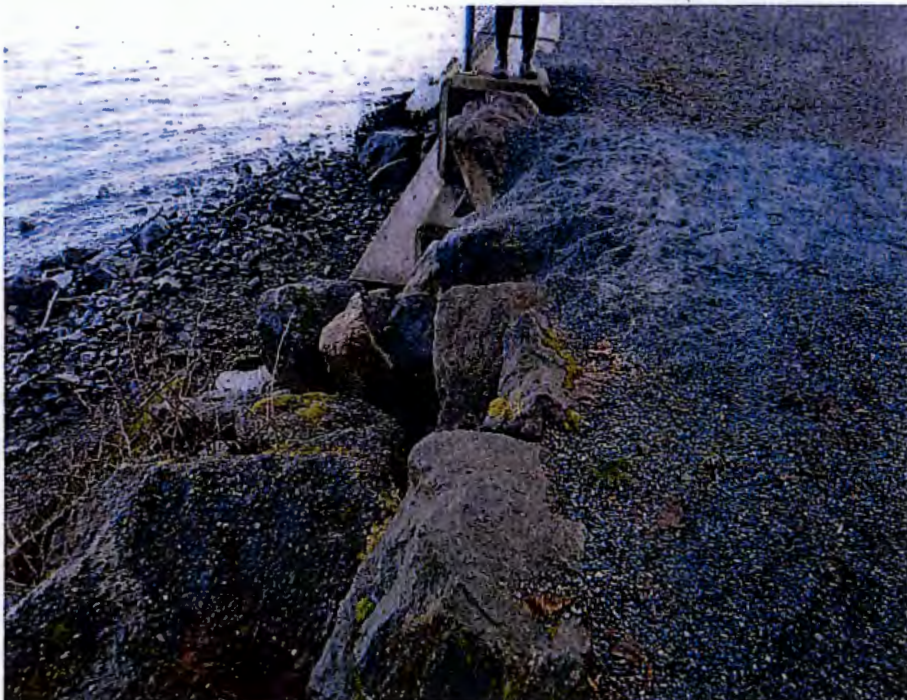
Figure 3.6 Zone 2 – Repairs to the top of the slope adjacent to the Miami Creek outlet.

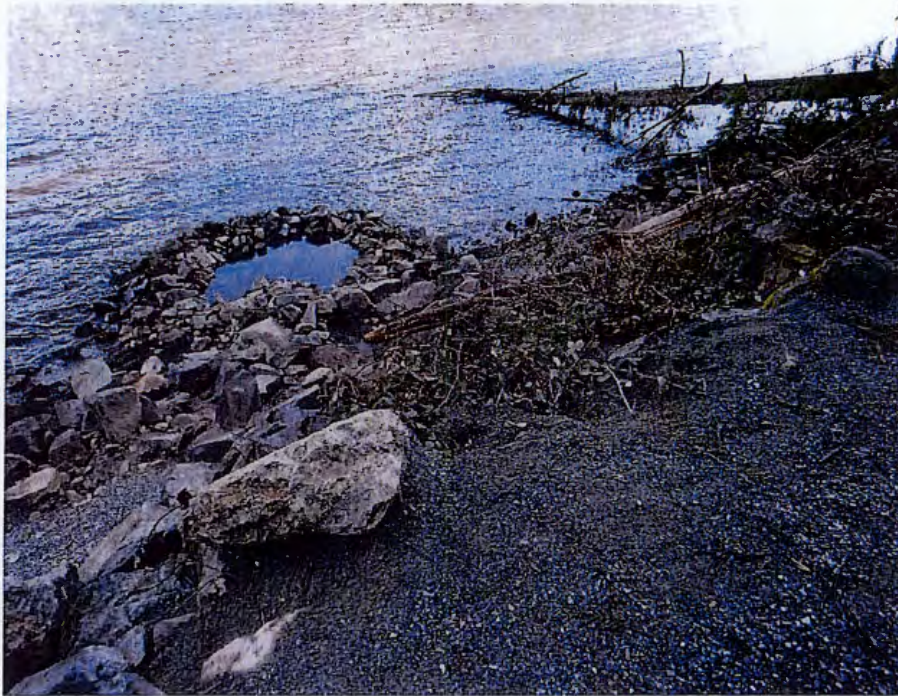
- Additional damage to the structure was observed at a location where pieces of the riprap slope had been removed by the public in order to build a pool structure. (Figure 3.7)

Figure 3.7 Zone 2 – Rock from the riprap slope removed to create warm pools.

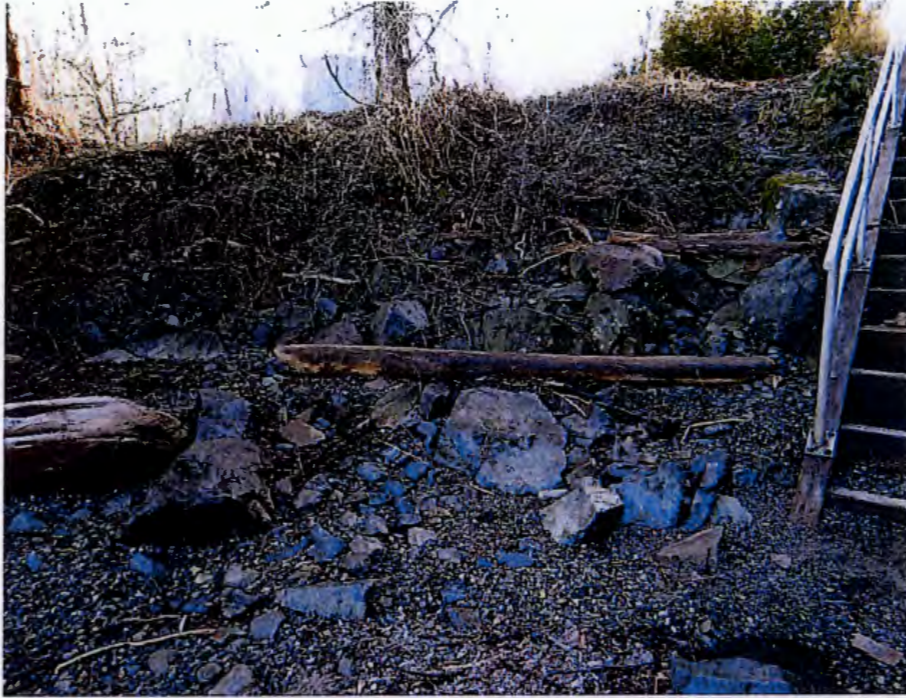
- The riprap was found to be in especially poor conditions in two locations: to the east of the Miami Creek outlet (Figure 3.8, Figure 3.9, Figure 3.15) and the very easternmost section of the zone (Figure 3.10) adjacent to the marina access peninsula. At both locations intermittent larger riprap ( $D_{50}$  of 400 mm to 700 mm) was scattered across the slope and smaller rocks and fines were visible.

- Vegetation, such as the invasive blackberry (Figure 3.8) and small diameter trees were observed along the top of the slope and could be responsible for displacing some of the rock material. The vegetation also makes it difficult to assess the condition of the slope.

Figure 3.8 Zone 3 – Invasive species covering the deteriorated riprap slope.

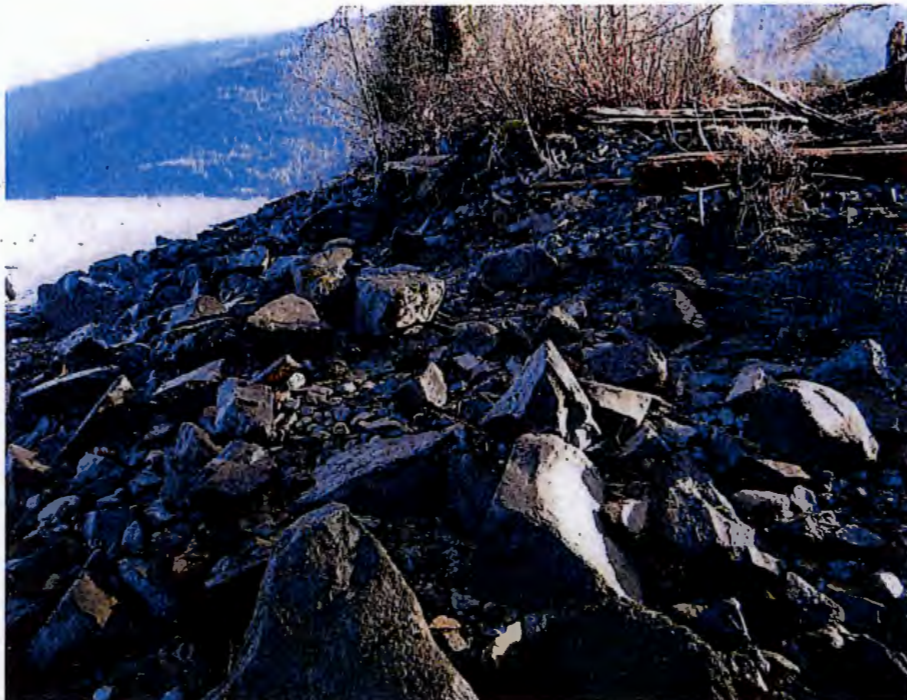
Figure 3.9 Zone 3 – Deteriorated riprap slope

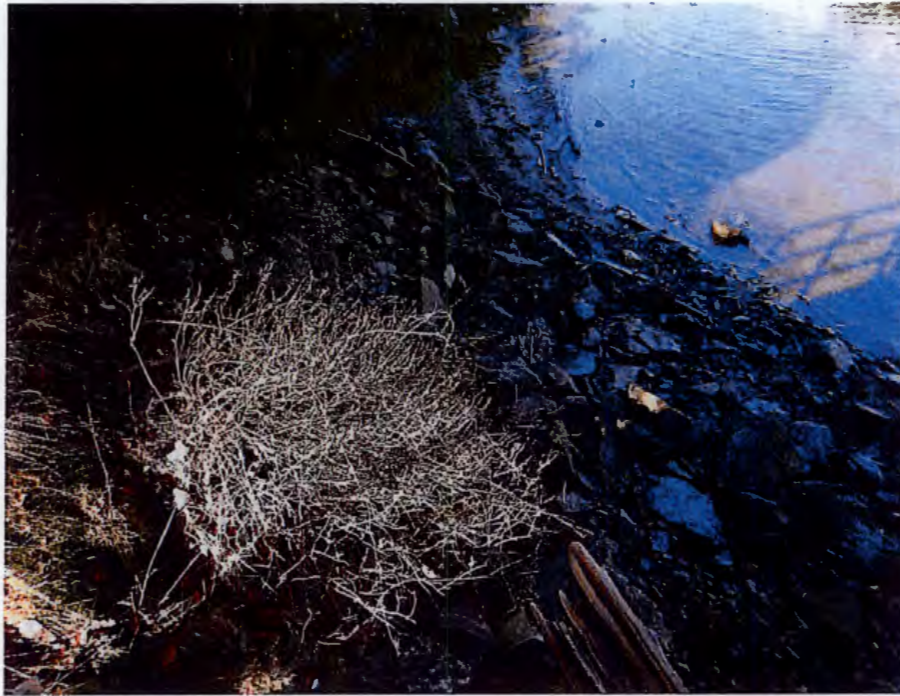
Figure 3.10 Zone 3 – Riprap in poor condition at the eastern extent of zone 3 adjacent to the marina access peninsula.

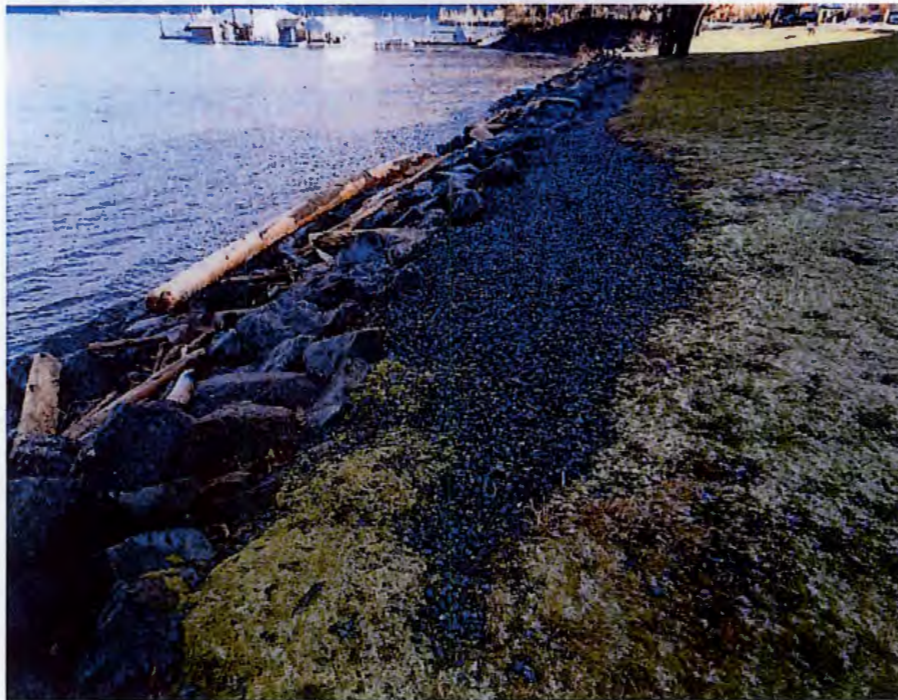
- The riprap in front of the Harrison Hot Springs Resort was observed to be in reasonable condition; however, it appears that repairs have been made to the top of the slope. It is assumed that these repairs were to replace fines/ground soil that washed out through the structure due to the lack of a filter layer. (Figure 3.11)

Figure 3.11 Zone 3 – Assumed repairs to top of riprap in front of Harrison Hot Springs.

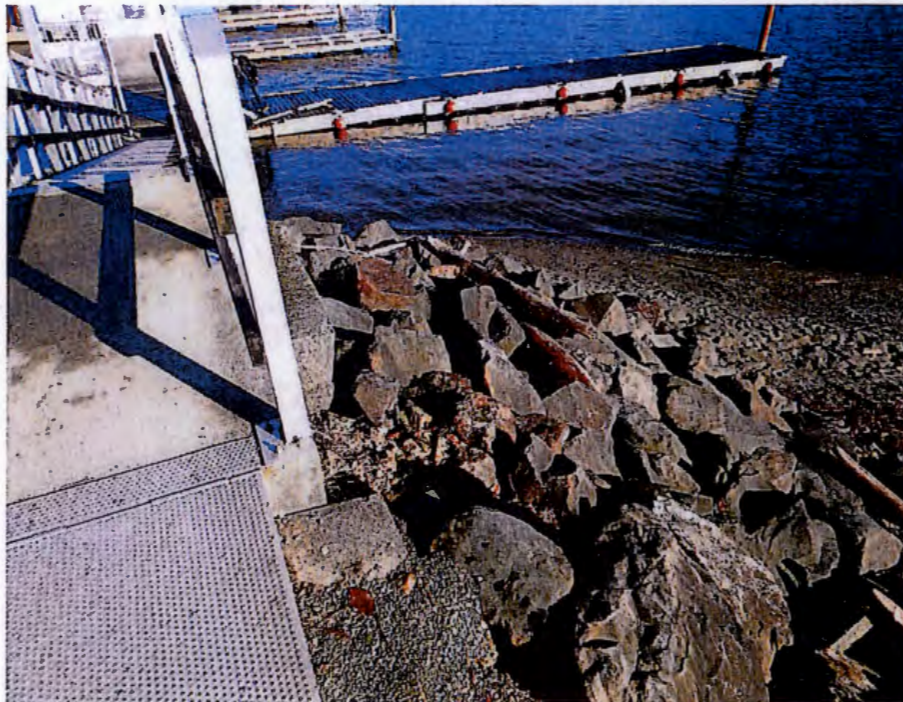
Figure 3.12 Zone 4 – Riprap protecting marina gangway abutment.

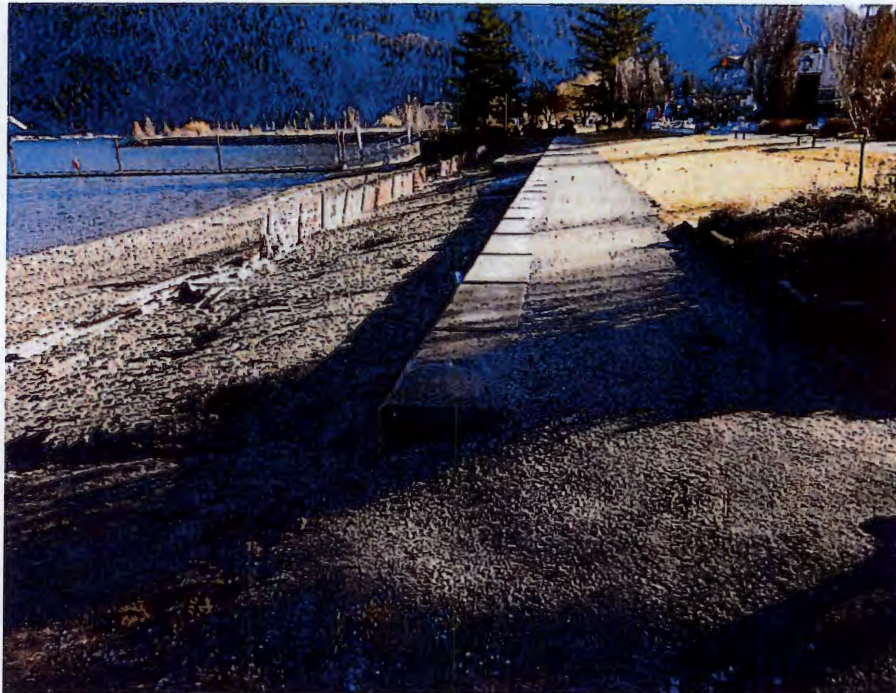
Figure 3.9 Zone 4 – Beach with lock-blocks (scour in front of lock-block is visible) and wooden slat fencing.

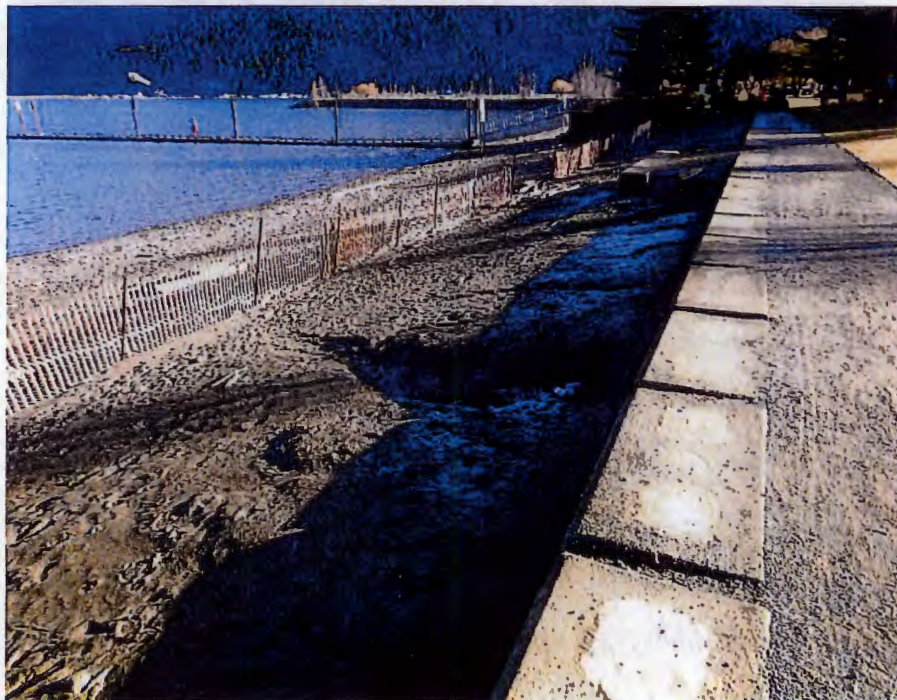
- The beach has experienced deflation (lowering). It is assumed that this is predominantly due to aeolian (wind) sand transport from the wooden slat fencing that has been installed to retain sand. (Figure 3.13)

Figure 3.13 Zone 4 – Lock-block wall with scour occurring in front.

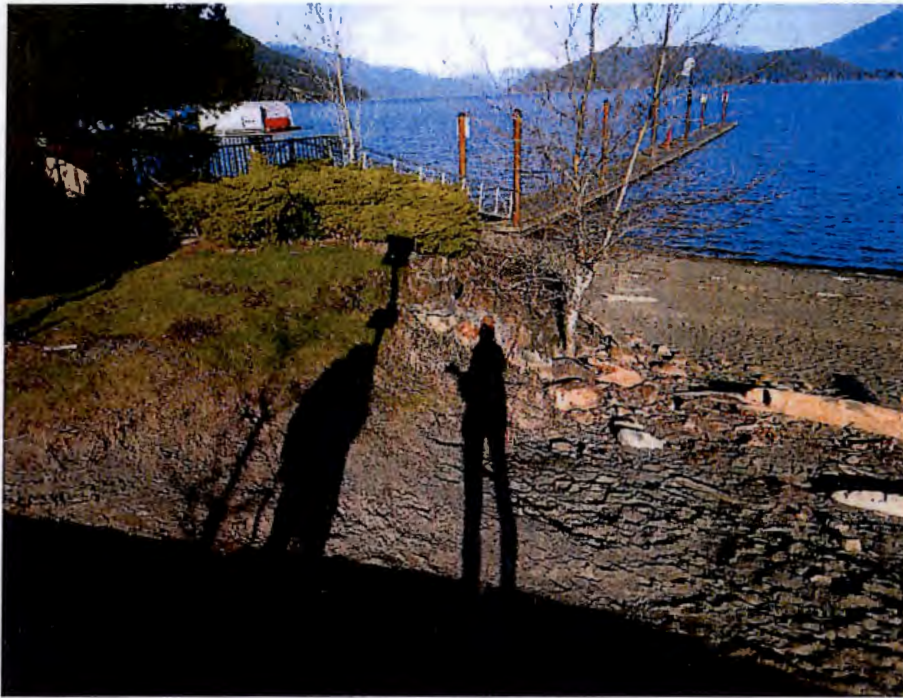
Figure 3.14 Zone 4 – Headland for the floatplane infrastructure.

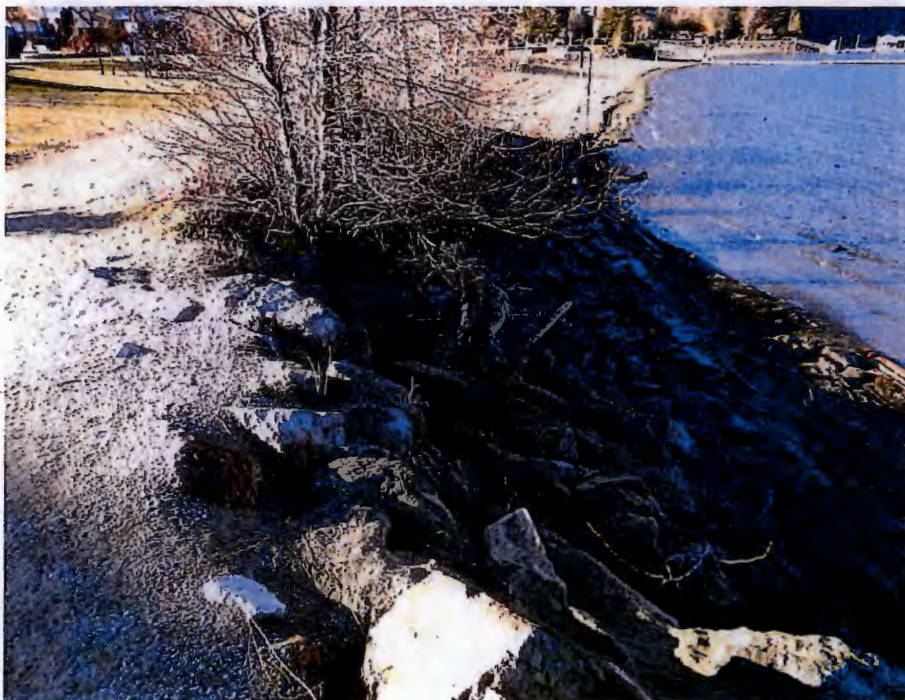
- The riprap at the eastern extent of the beach (where the beach connects to the Harrison Lagoon) is in moderate condition. Repairs have been made to the top of the slope where it appears fines have been washed out through the rock at the top of the slope. (Figure 3.15)

Figure 3.15 Zone 4 – Riprap slope at the transition to the Harrison lagoon.

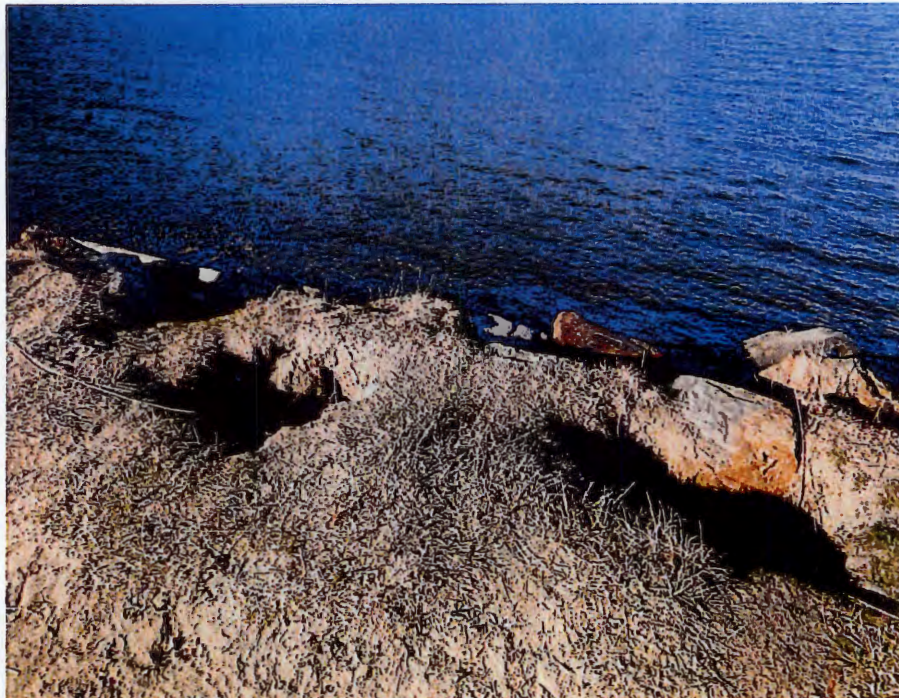
- Observed locations of riprap movement and washout, such as fine material from the lagoon berm pathway being sucked out through gaps (due to no filter layer) in the riprap slope (Figure 3.16, Figure 3.18)
- Some variation in the sizing of riprap was observed here although less than what was seen in zone 3. Overall, the average rock size ( $D_{50}$ ) varied from 200 mm to 700 mm (Figure 3.17). Large rocks have been added at the top of the slope where damage has occurred.
- Similar to in zone 4, scour was observed in front of the existing lock-block walls on the beach that backs the lagoon. At this location the scour is unlikely to be from wave action and is assumed to be due to surface water run-off. (Figure 3.19)

Figure 3.16 Zone 5 – Observed erosion at the top of the riprap slope on the lagoon berm.

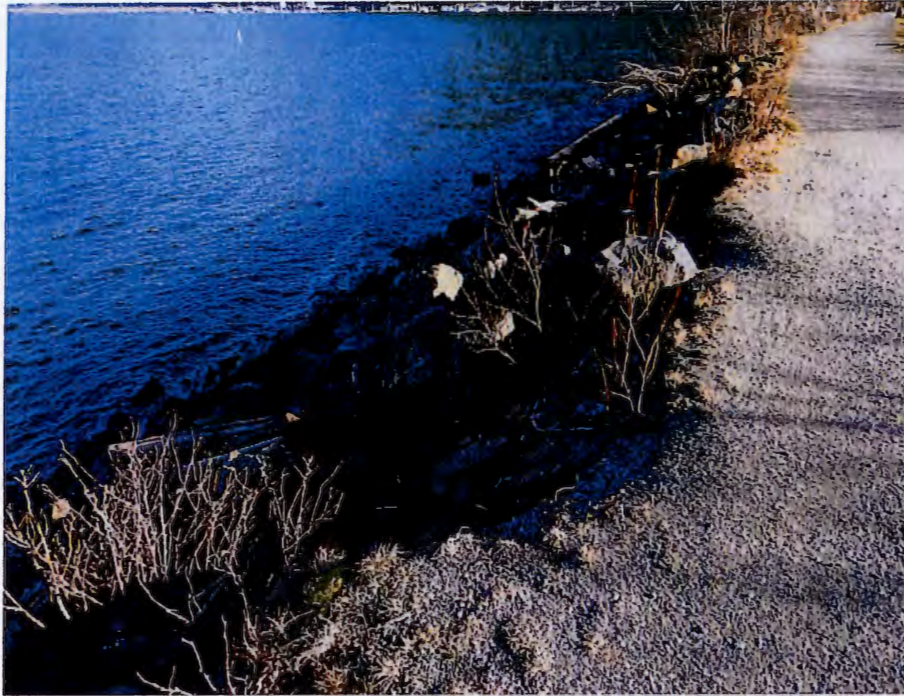
Figure 3.17 Zone 5 – Variation in sizes of riprap on the offshore slope of the lagoon berm.

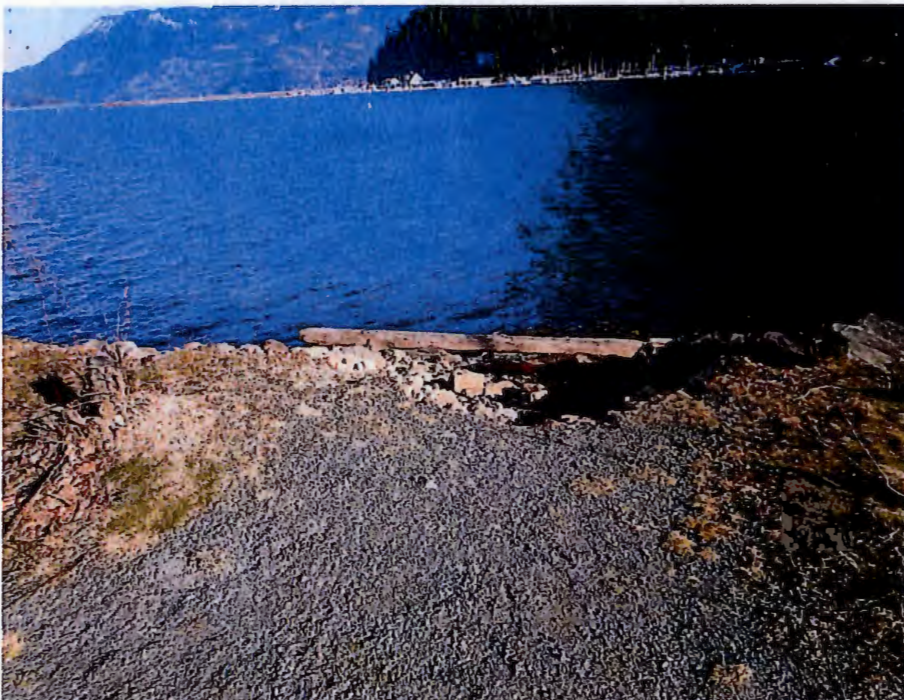
Figure 3.18 Zone 5 – Observed location of erosion in the lagoon berm.

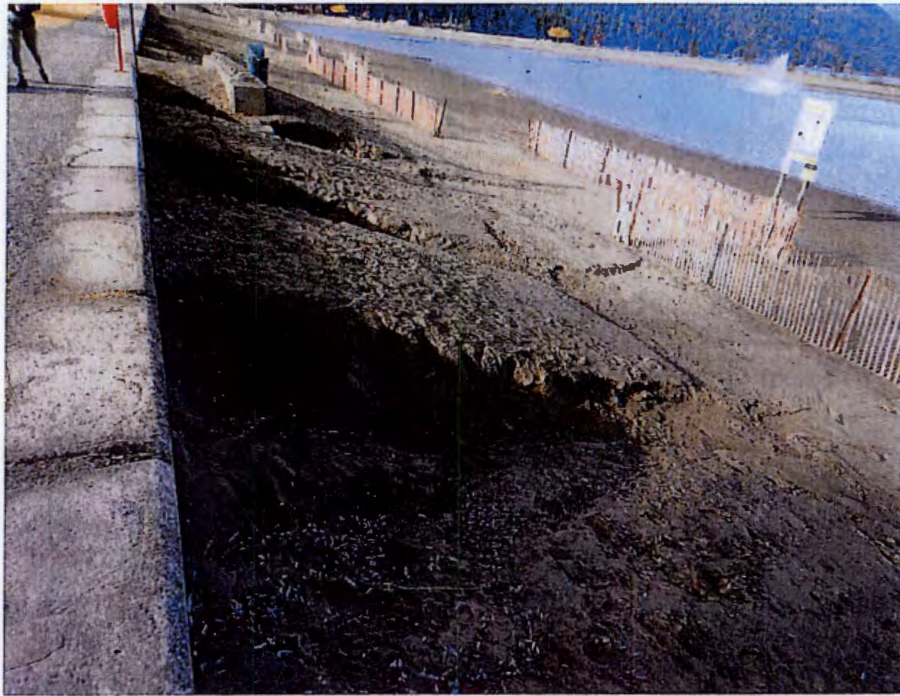
Figure 3.19 Zone 5 - Existing lock-block wall and wooden slat fencing along the dike in front of the lagoon with severe erosion.

Note that a couple of changes are planned for this section in the short term including in front of the public washrooms where another lock-block wall will be installed to prevent further erosion (CTQ Consultants Ltd., 2022).

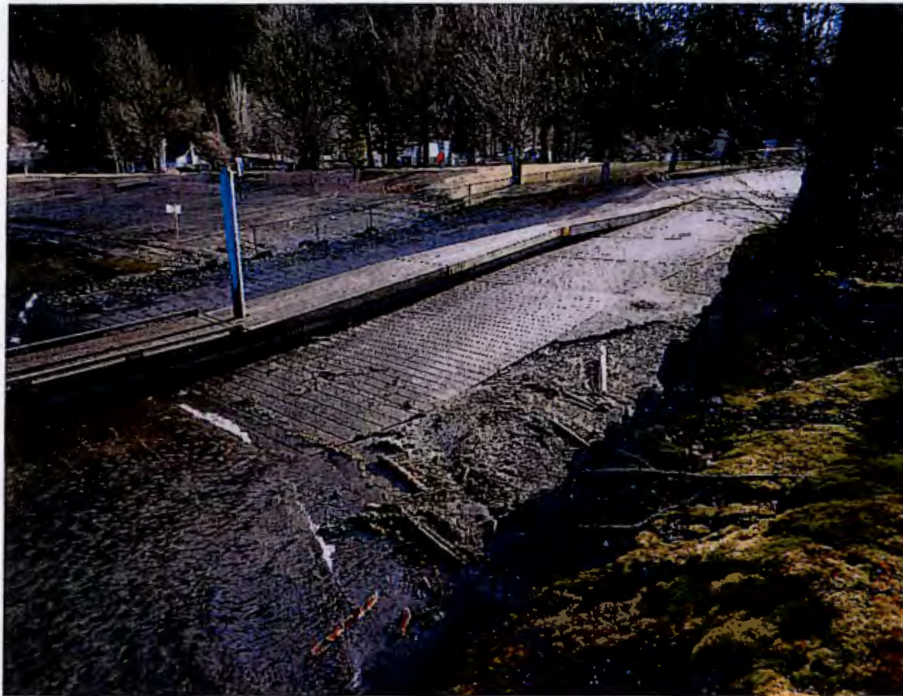
- A two lane boat launch intersects the dike. (Figure 3.20) This was identified in the dike assessment project (NHC, 2015) as encroaching and will need to be assessed for the impact on the dike.
- There is a stormwater outflow pipe on the beach which appears to act as a groyne; as a result sediment has collected on the west and eroded to the east. (Figure 3.21) This results in the homes to the east of the structure being more exposed to wave events.
- Residential properties are closer to the top of dike than in other zones. (Figure 3.22)
- Erosion is occurring at the top of the beach. (Figure 3.23) This appears similar to the surface run-off erosion witnessed in zone 4.
- Aeolian sediment transport is also a concern in this zone based on the wooden slate fencing. (Figure 3.23)

Figure 3.20 Zone 6 – Boat launch.

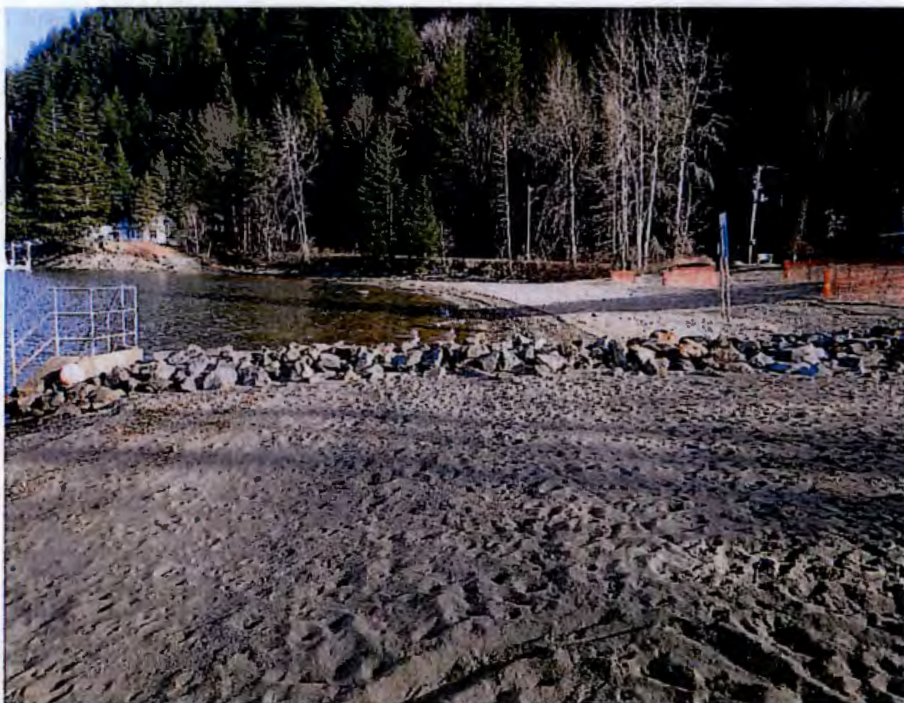
Figure 3.21 Zone 6 – Discrepancy in beach elevations due to water outfall pipe

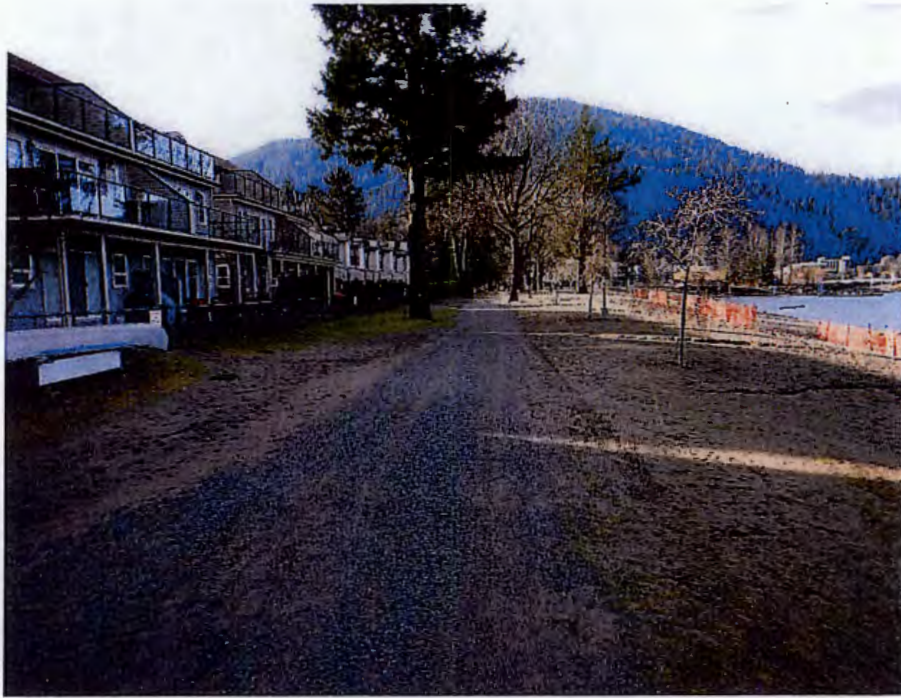
Figure 3.22 Zone 6 - Residential properties directly behind the top of dike.

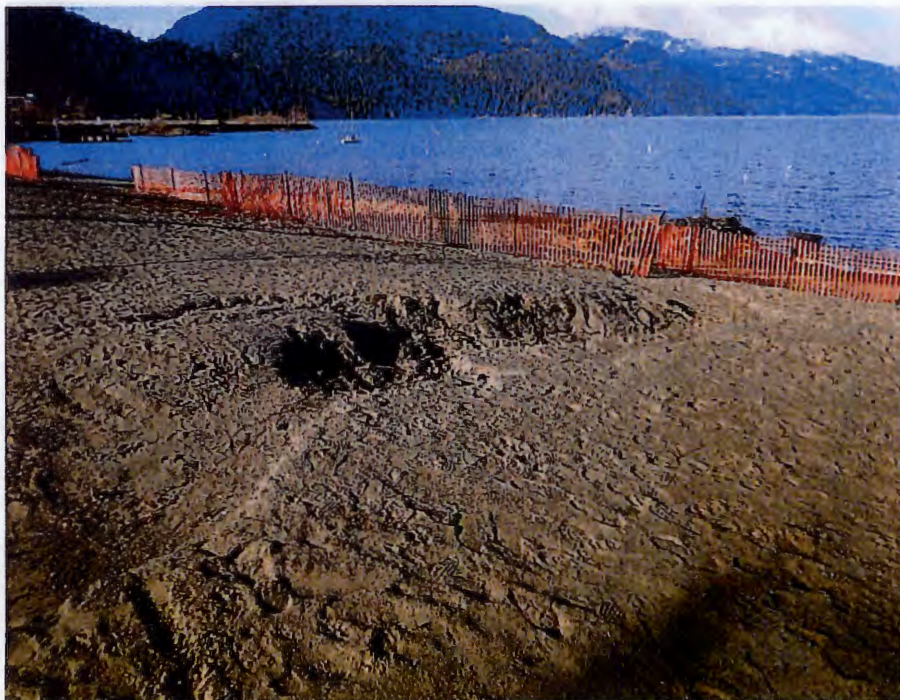
Figure 3.23 Zone 6 – Scour occurring at the top of the beach.

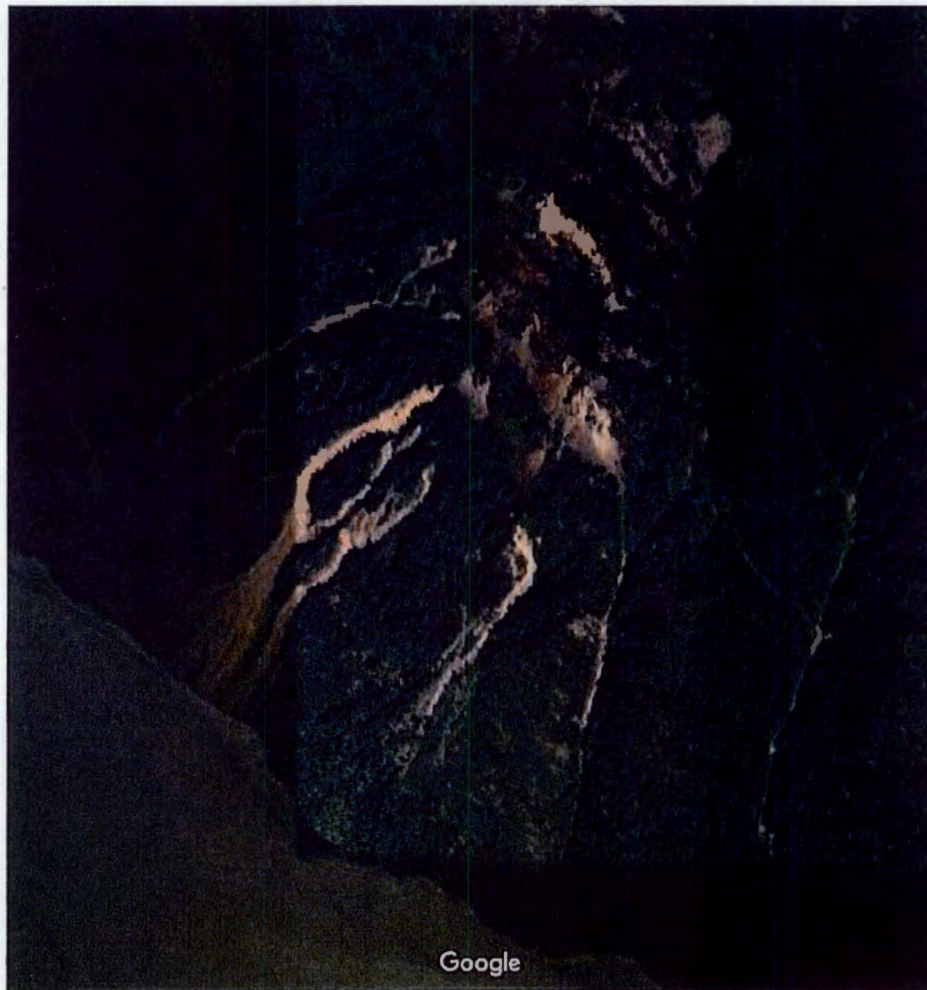
A 1990s investigation by Emergency Management BC found that there is a large mass of rock, called a sackung, moving slowly down the southwest side of Mt. Breakenridge (Figure 6.1) on the north end of Harrison Lake (Kennedy, 2021a). This sackung is identified as being on the steep, lake side of the mountain, in the summit ice fields showing fault-like ridges believed to be tension cracks due to instability (MtnPg.asp, n.d.). If the entire mass were to suddenly slide down the mountain, it is estimated it would trigger a displacement wave with wave heights of 20-25 m at Echo Island, 5 km off the coast of the village reaching the village and other exposed communities around the lake in under 20 minutes (FVRD, 2021). The village does have some natural protection, such as Echo Island and the natural shoal (created by Fraser River sediment depositing into the lake through Harrison River) (Kennedy, 2021a); however, it is still expected the dike would be overtopped by 2 meters, and that the wave would move through the village in under two minutes, with speeds of up to 5m/s (Kennedy, 2021a).

Figure 6.1 The Mt. Breakenridge hazard slope, showing past landslide scarring and possible tension cracks (GoogleEarth image from June 29, 2017).

NHC recommends that at a minimum, item 1 (slope stability monitoring) be put into place at Mount Breakenridge.
