Harrison Hot Springs Waterfront Flood Mitigation

Update to Council

April 17, 2025

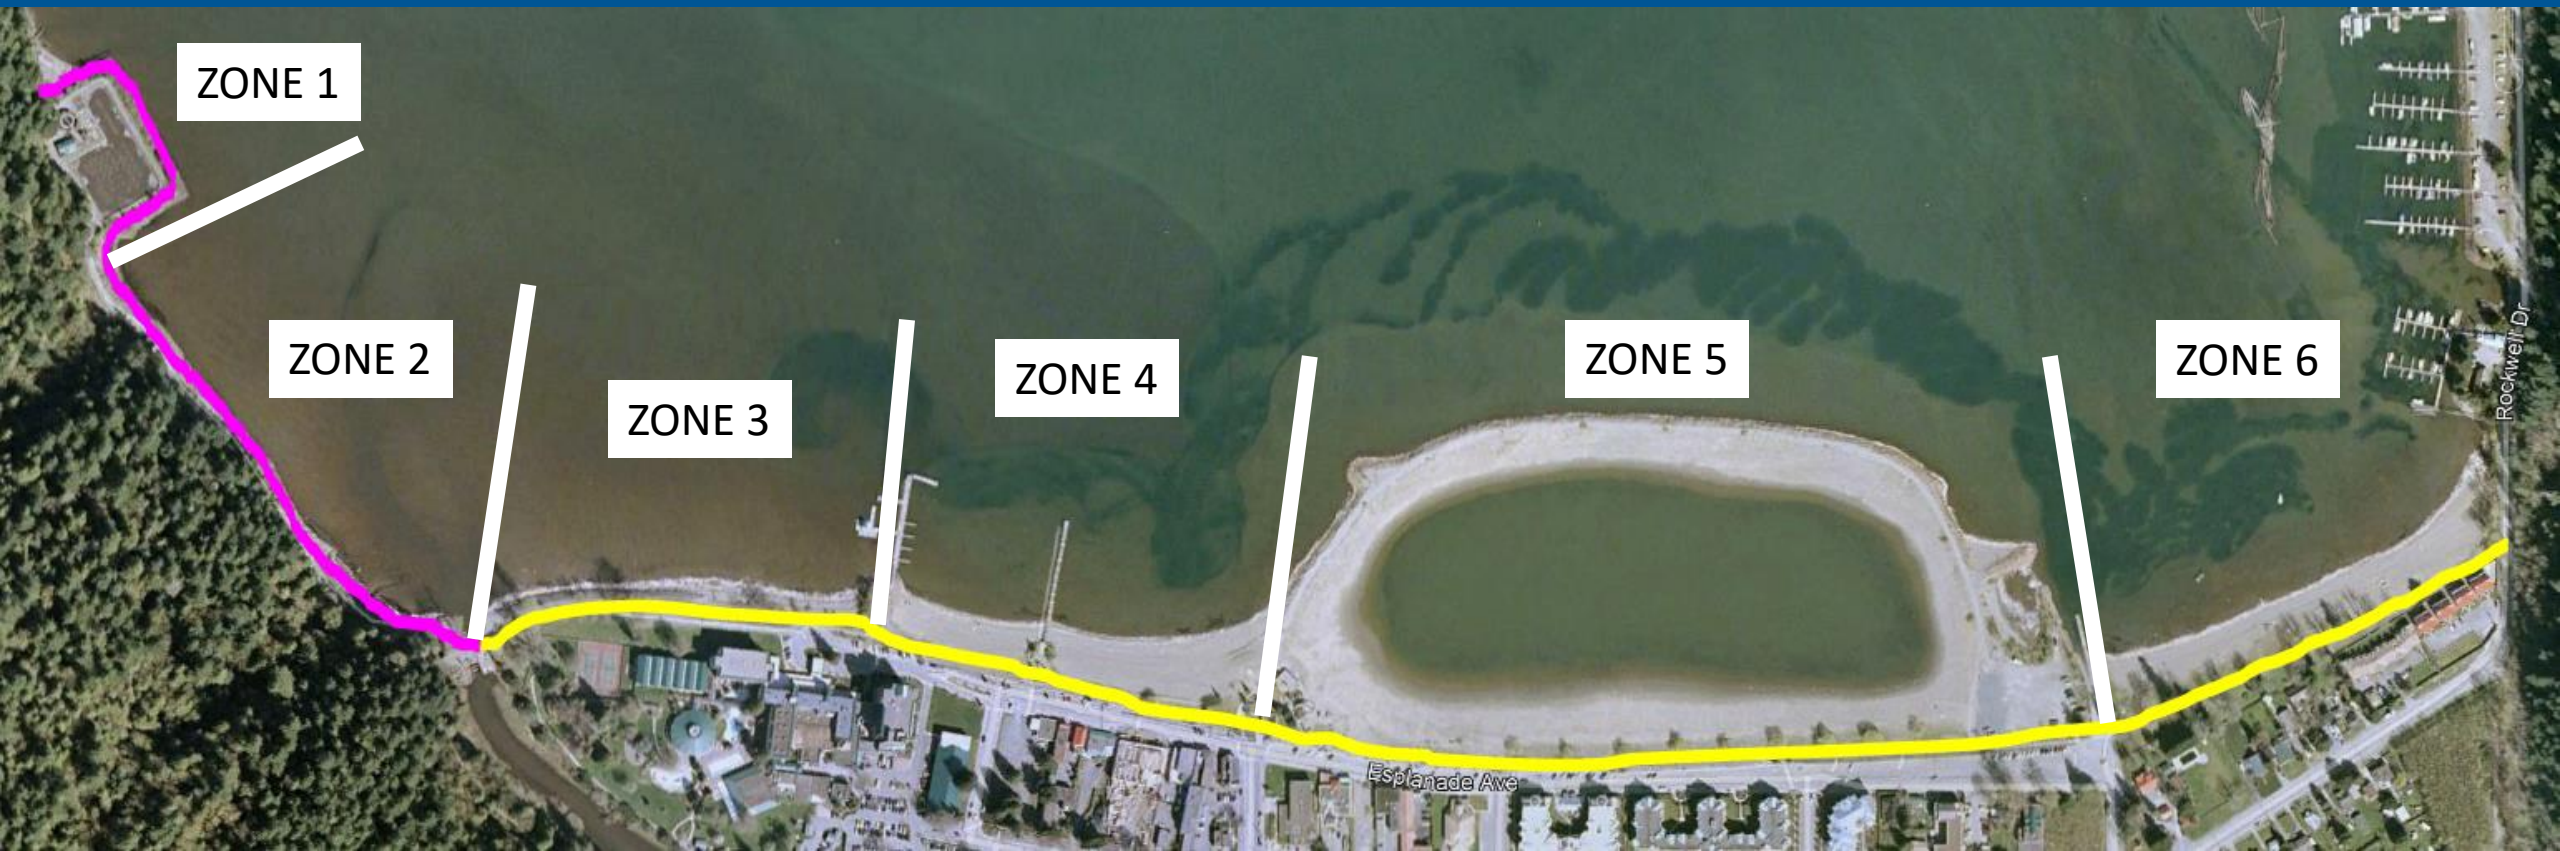
Project Overview Components

WWTP Road and Shoreline + Rendall Park earthfill dike (Zones 1, 2 and 6)
– **Council has directed staff to proceed with design**

Waterfront Dike (Zones 3, 4, 5)
– ***Design concepts under discussion***

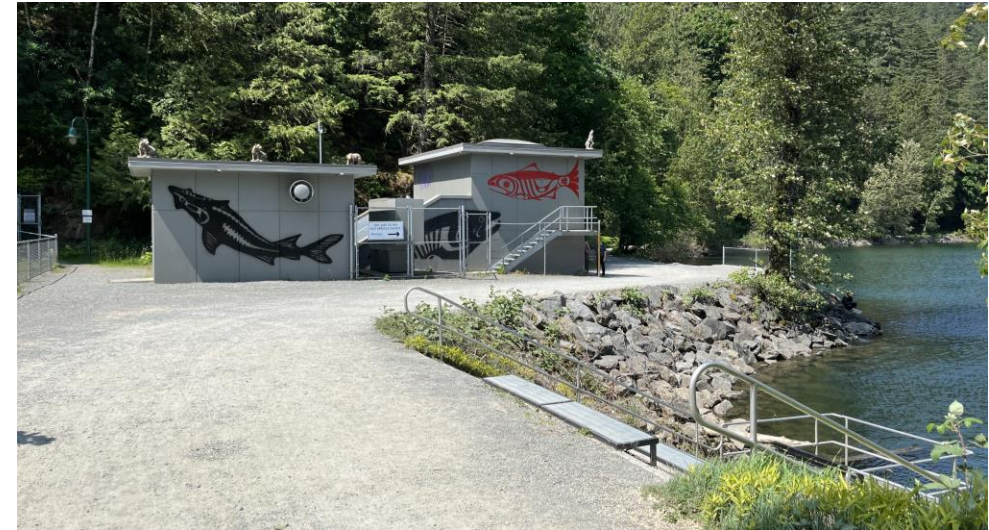
- **Design Event: Fraser River freshet flood**
(spring/early summer snowmelt)
- **Other flood hazards**
 - **Harrison Lake inflow flooding (fall/winter)**
Also managed by dike, but water levels lower
 - **Local stormwater/drainage, Miami River**
Managed by pump station/floodbox
(upgraded 2016, designed for 200-year Miami River flow)
 - **Landslide generated waves**
Slope failure along Harrison Lake shoreline (tsunami wave, up to 20-25 m high) – not managed by dike
